Property Description: (2) story single family home with daylight basement
Estimated property age: Built 1996 per listing
Occupancy Status: Occupied (staged)

Inspection Date: 08/11/2019
Inspection Time: 12:00 P.M. - 2:30 P.M. +-
Weather Conditions: Overcast, 70 deg f +-

Hergert Inspection LLC

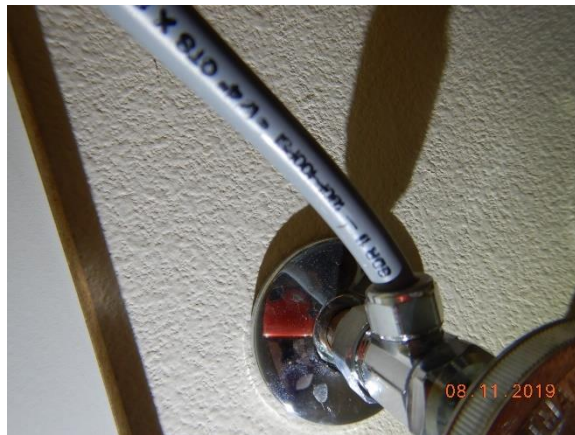
- The supply lines to most of the bathroom sinks are polybutylene pipe. This type of pipe is a known defect as it tends to fail. Recommend replacement (this does not involve changing pipes within the wall)

Polybutylene pipe @ sinks

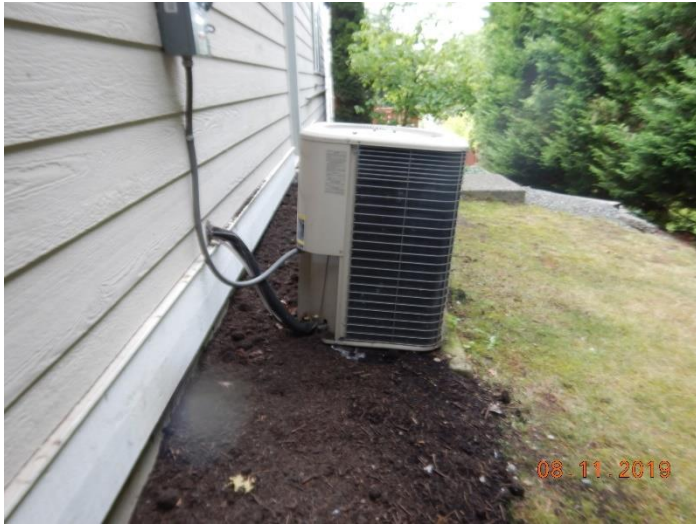
- The age of the furnace is 23 years. The remaining anticipated useful life expectancy is 2 years. The age of the air conditioning compressor is 15 years
- Recommend furnace and air conditioning systems to be cleaned, serviced, and shown to be in good working order by a qualified furnace technician. The last service date for the systems was in 2015 per the tag on the furnace
- The air conditioning system compressor is not level which can result in premature wear of the system

The compressor is not level

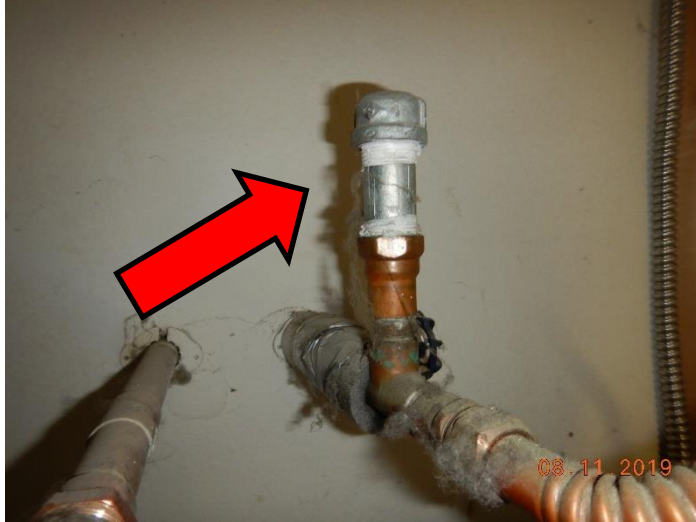
Flue secure: Inspected
Clearances: As required where visible
Draft Hood: Inspected
Water connection: Inspected
Expansion Tank: - New water heater tank installations typically require an expansion tank be installed. The tank absorbs pressure as hot water expands. It appears that a prior expansion tank has been removed
Drip pan: Installed

Appears that an expansion tank was removed from this location above the water heater

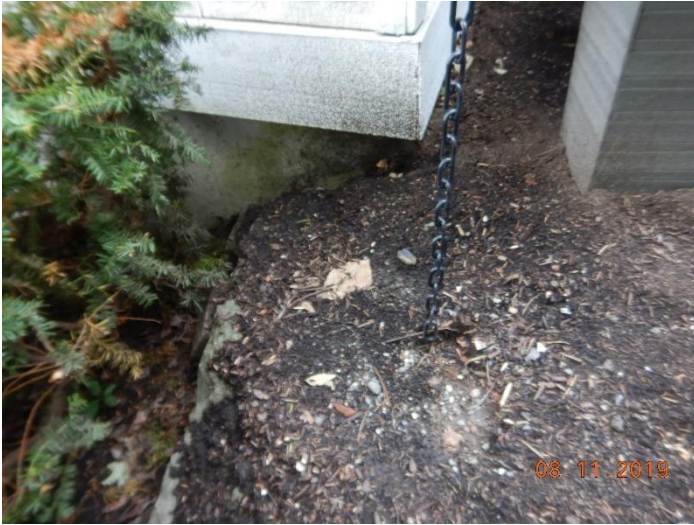
Downspout chain. No splash-block or drain is provided (WDO conducive condition)

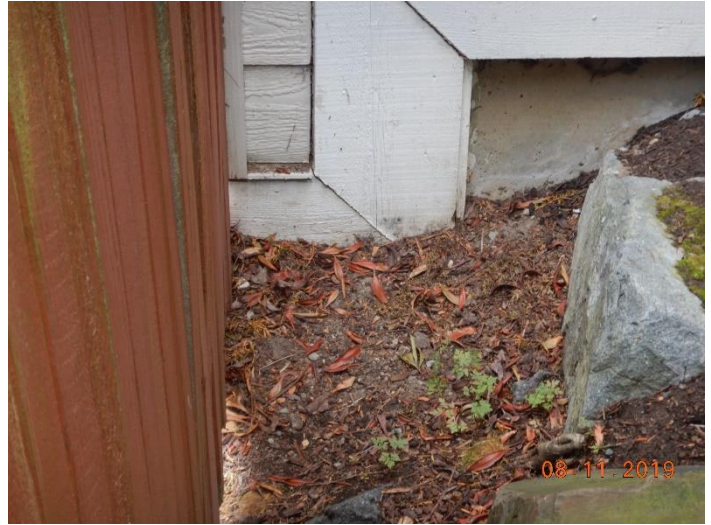
- Grade at structure: Adequate grade away
- Earth to wood contact: - Ground in contact with the siding (WDO conducive condition). Recommend 4-6" separation between the ground and siding
- Recommend installing a drainage system at the front corner of the Living room sitting area that would divert water away from the home and prevent water from splashing back onto the siding
- Vegetation contact: Negligible
- Roof drain discharge: Underground and surface discharge

Ground in contact with the siding (WDO conducive condition)

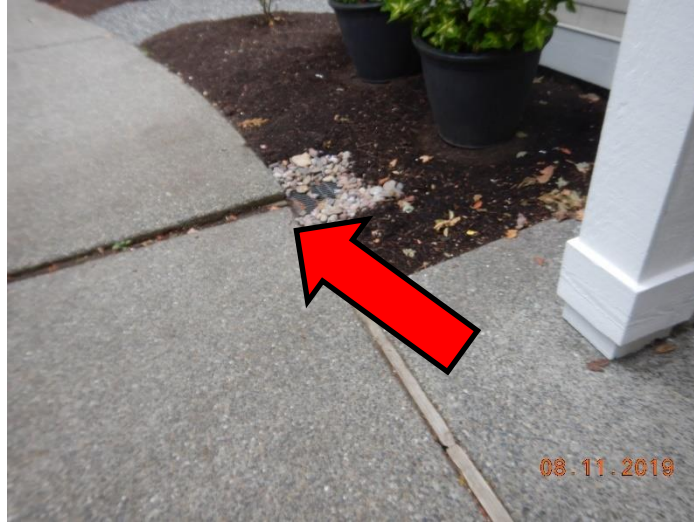
- Type: Concrete
- Condition: Satisfactory
- Trip Hazard: - There is substantial settlement of the front porch and walkway. A trip hazard exists due to the raised edges at the slabs

Trip hazard

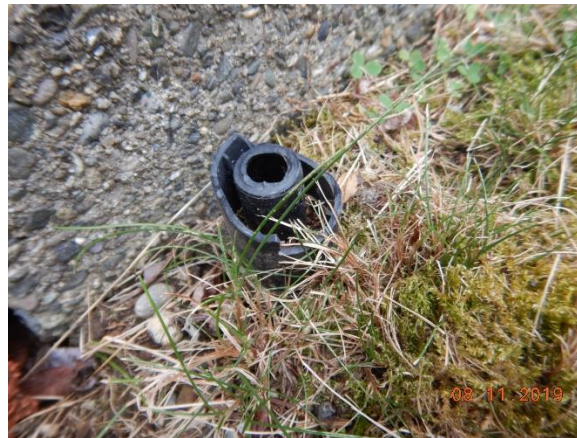
House Identification #: Visible
Overhead Power Lines: No
Retaining Walls: None that affect structure
Underground Oil Tank: No visible evidence
Irrigation System: - Seller should demonstrate that the irrigation system operates as designed and explain all winterization procedures as may be applicable. Some irrigation heads appear to be damaged

Damaged irrigation head

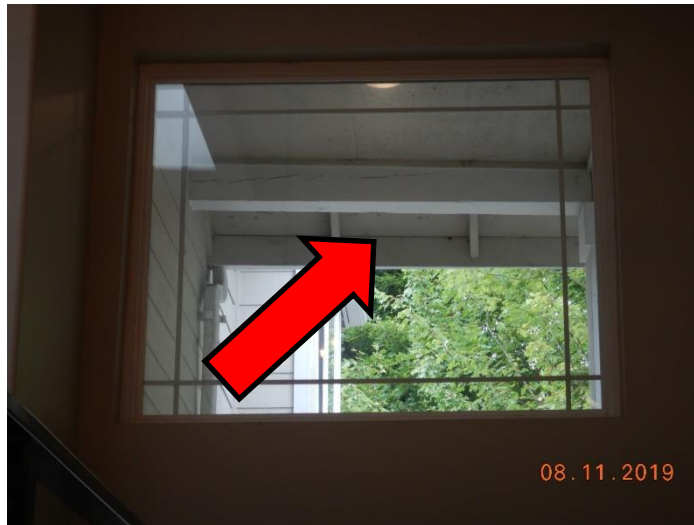
- Structural Movement: - There is evidence of settlement of the front porch. No adverse issues to the structure were identified as a result of this settlement. The settlement is likely related to the settlement at the adjacent slabs
- Exterior doors: Satisfactory
- Windows (ext. cladding): Satisfactory

Evidence of settlement (sloping beam)

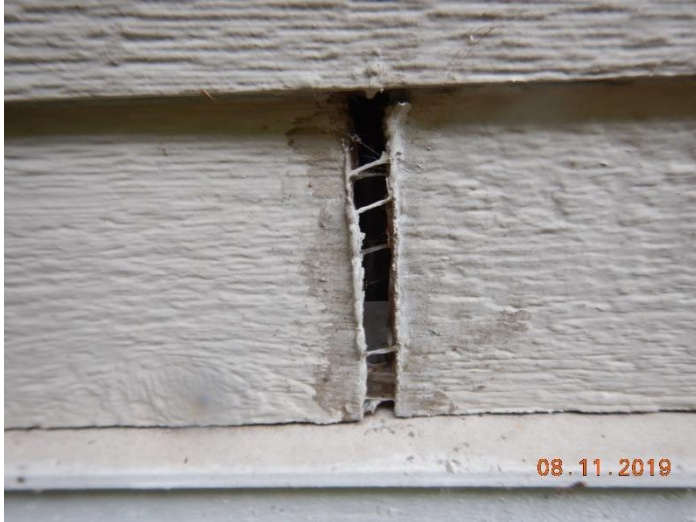
Gaps at the end joints should be caulked

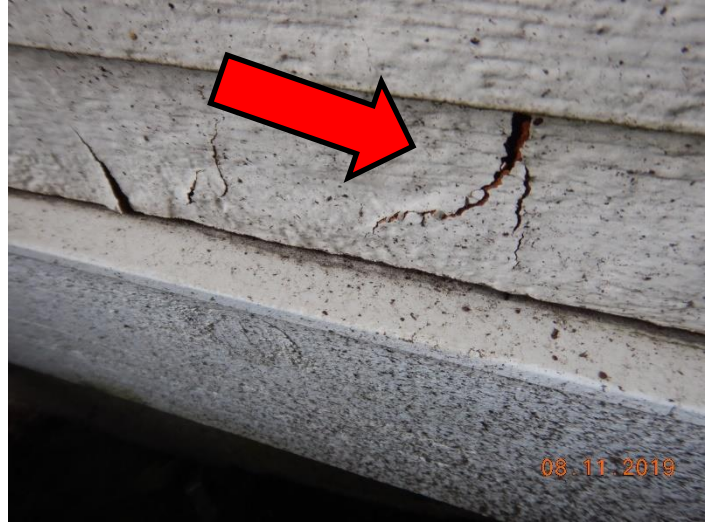
- Type: Composite
- Condition: Overall satisfactory
- There is evidence of siding failure where adjacent to the uncontrolled downspout located at the outer corner of the Living room sitting area
- Window/Door Flashing: Satisfactory
- Paint and caulking: - The end joints of the siding should be caulked as needed
- Exterior vents: Satisfactory

Failed siding at the Living room area

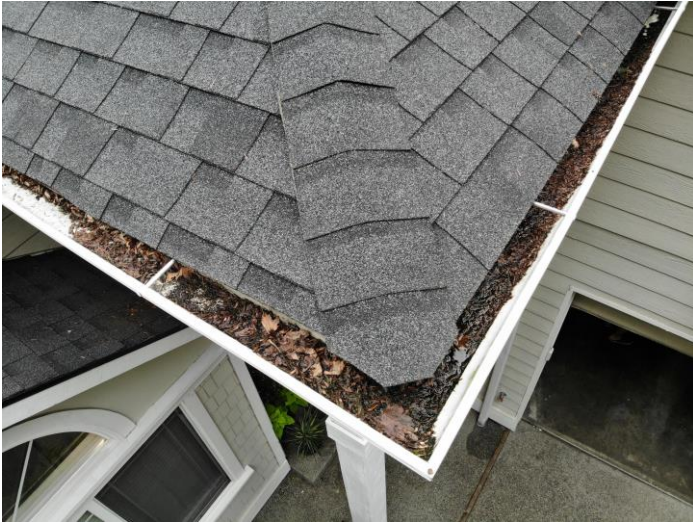
Debris in the gutter above the entryway

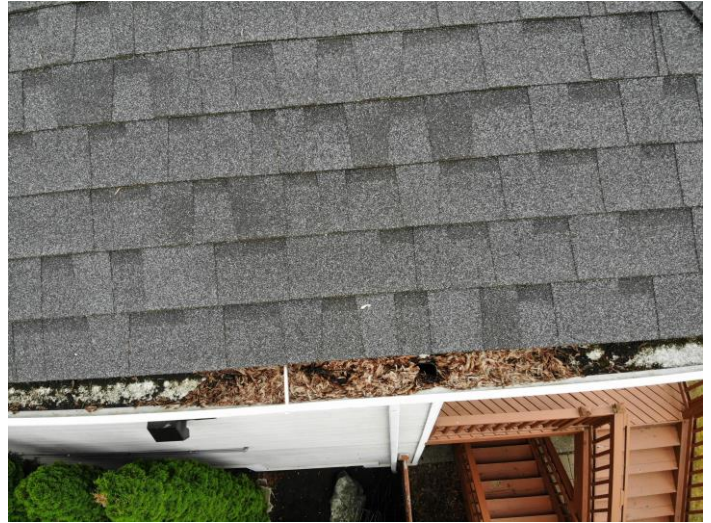
Debris at an upper rear gutter

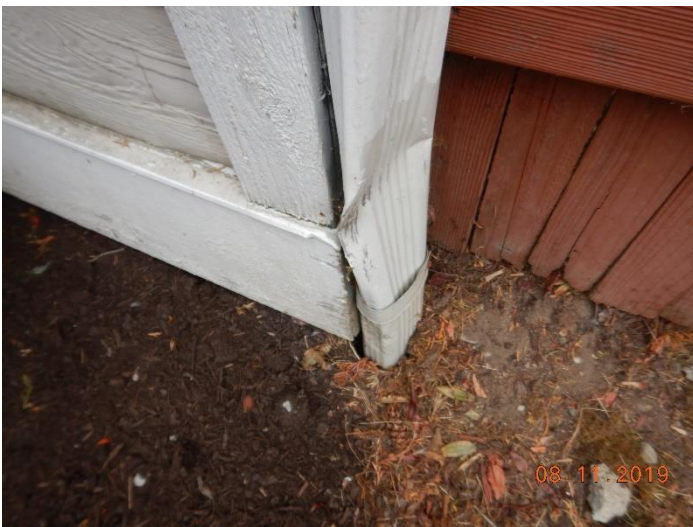
A downspout at the rear of the home is crushed, however appears to service its intended purpose

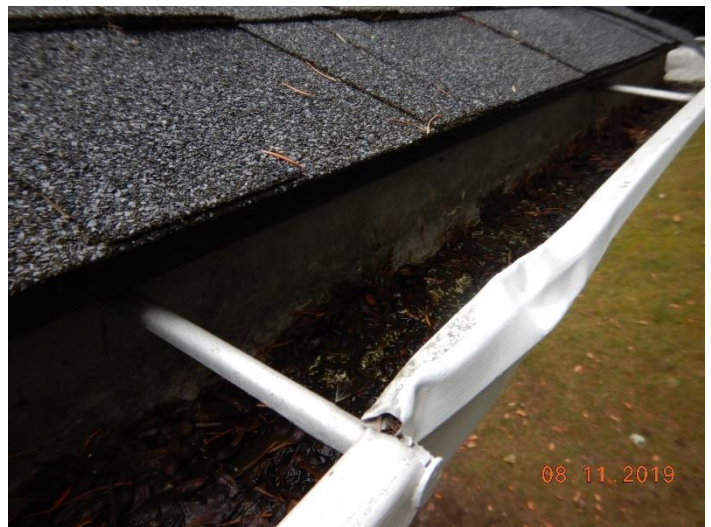
- Seller: explain the dent located at the gutter located at the driveway side of the garage. An old moisture stain is visible at the siding in this location

Dented gutter

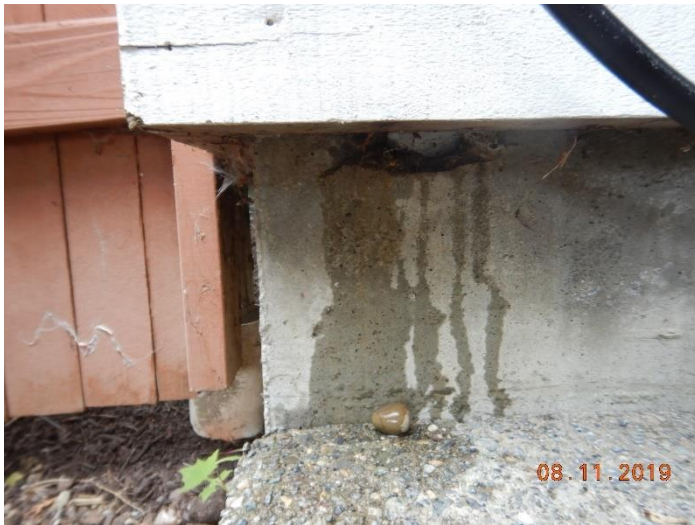
- The rear hose bib appears to have an internal crack and substantially leaks into the adjacent wall when active. Recommend immediate review and repair by a licensed plumber (inspector turned off the water supply to the home as the sound of running water could be heard even with this valve set to the off position). See the related comments in the Basement bedroom section

Water running from the siding at the rear hose bib

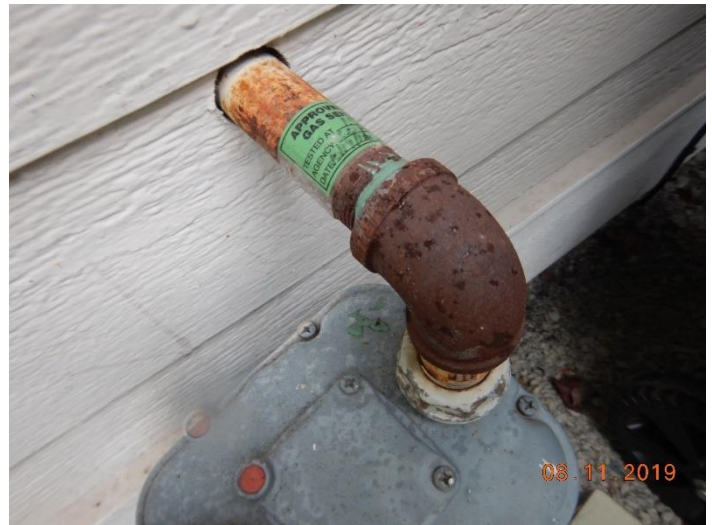
Rusting gas pipes

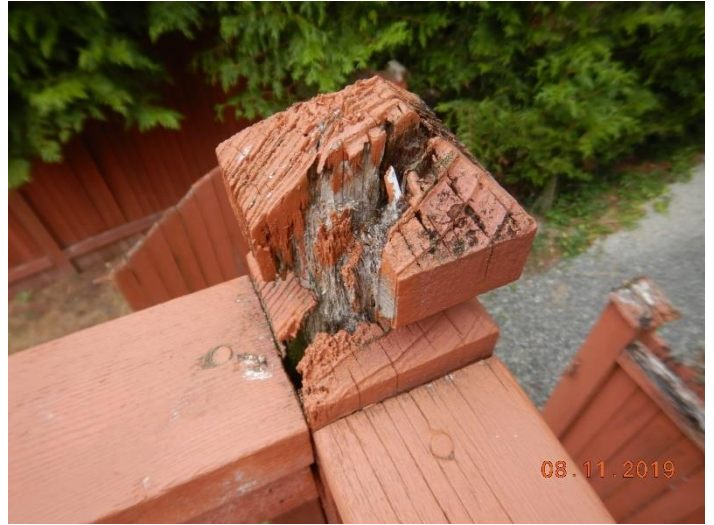
- Structure: Pressure treated joists, beams, and posts
- Decking: Cedar
- Condition: Overall satisfactory
- There is evidence of wood rot at the top side of several barricade posts at the deck
- Connection to structure: The deck appears to be adequately secured to the home with lag bolts
- Trip Hazard: None identified
- Handrails: A reasonable graspable handrail is installed
- Barricades: A reasonable barricade is installed

Rotting barricade post (typical)

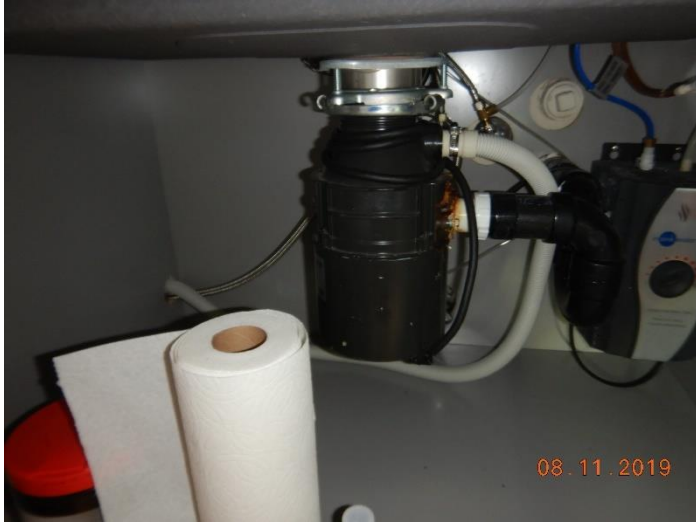
Dishwasher: Tested a full cycle. Not all functions and settings are tested
Dishwasher drainage: - The dishwasher drain should be secured to the underside of the countertop to prevent cross contamination of waste water with the dishwasher (high loop)
Cooktop: Tested all burners
Oven: Tested. Not all functions and settings are tested
Microwave (door): The door of the microwave was tested for operation
Ventilation: Tested
Refrigerator: - Seller: Is there a water supply to the refrigerator? If so, demonstrate this the supply and ice/water features of the refrigerator function as designed

Dishwasher drain

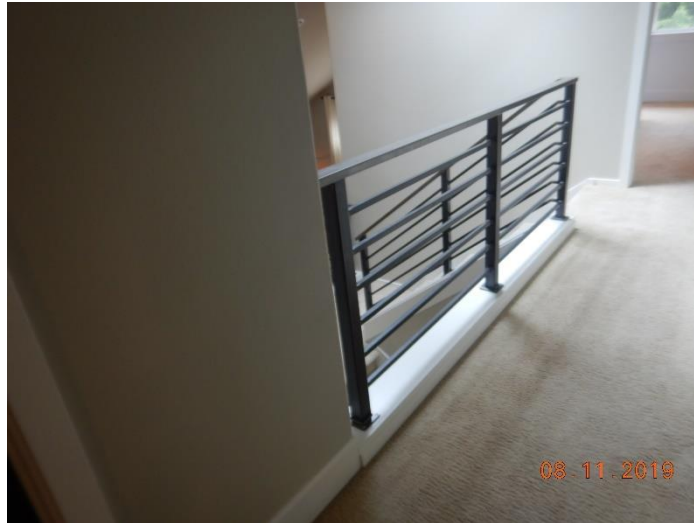
Barricades: - *Horizontal barricades are permitted by code, however can be a fall safety hazard as the style creates a climbing ladder*

Horizontal barricade

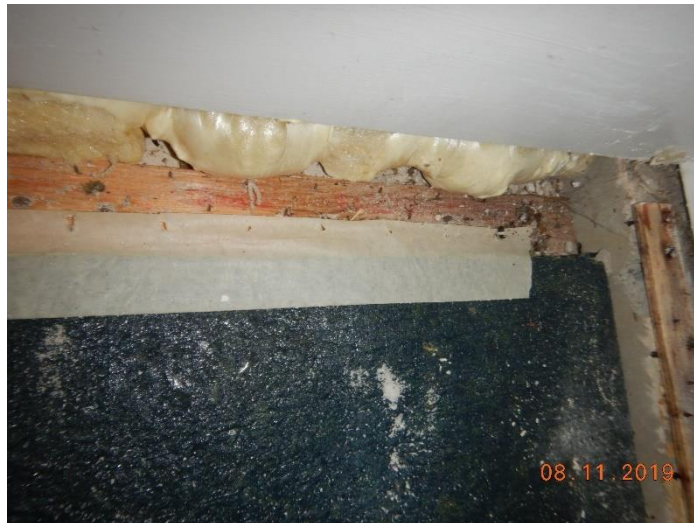
- Visibility: Room is occupied
- Structural Movement: - There is evidence of substantive settlement of the slab located in this space. Seller: explain the history of this settlement. Recommend further review and cost estimates to repair by a licensed contractor. Self leveling concrete should be used as slab jacking may result in damage to the primary waste line for the home
- Moisture Intrusion: No visible evidence
- Walls: Satisfactory
- Ceiling: Satisfactory
- Flooring: Satisfactory

Settlement of 2" +/-; expansion foam has been added. The carpeting was unsecured at the outer corner of the room

- There is evidence of substantive settlement of the slab located in this space. Seller: explain the history of this settlement. Recommend further review and cost estimates to repair by a licensed contractor. Self leveling concrete should be used as slab jacking may result in damage to the primary waste line for the home

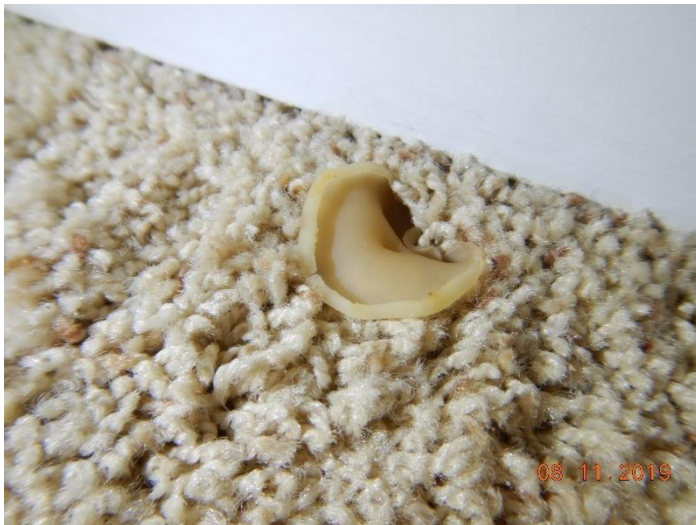
Mushroom growing from the carpeting

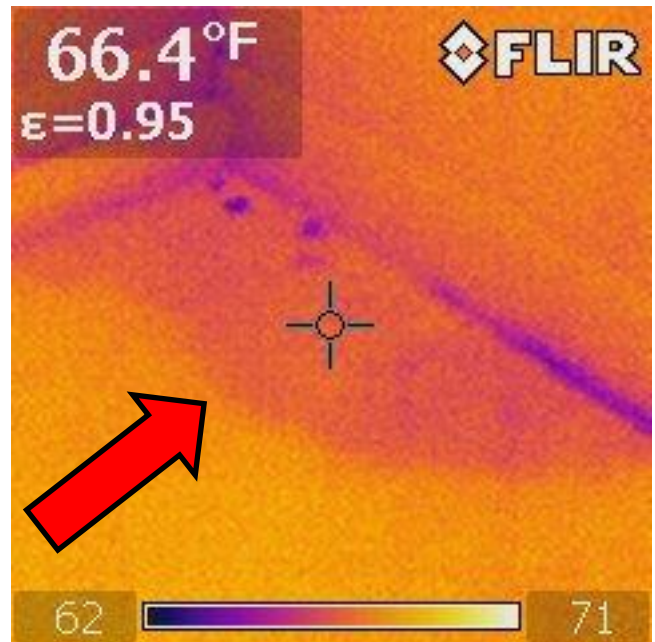
- Visibility: Room is vacant
- Structural Movement: No visible evidence of substantive structural movement
- Moisture Intrusion: - There is evidence of active moisture intrusion at the outer corner of the bedroom. The source of the moisture appears to be the damaged hose bib located at the outer wall at this area. All moisture damaged insulation, drywall, and carpeting pad should be removed and replaced
- Walls: Satisfactory
- Ceiling: Satisfactory
- Flooring: Satisfactory

Moisture at the carpeting
(outer corner of the room)

- There is evidence of active moisture intrusion at the outer corner of the bedroom. The source of the moisture appears to be the damaged hose bib located at the outer wall at this area. All moisture damaged insulation, drywall, and carpeting pad should be removed and replaced
- Recommend replacement of the smoke detector as it appears to be past its 10 year anticipated useful life expectancy
