Property Description: (2) story single family home with daylight basement
Estimated property age: Built 1996 per listing
Occupancy Status: Occupied (staged)

Inspection Date: 08/11/2019
Inspection Time: 12:00 P.M. - 2:30 P.M. +-
Weather Conditions: Overcast, 70 deg f +-

Hergert Inspection LLC

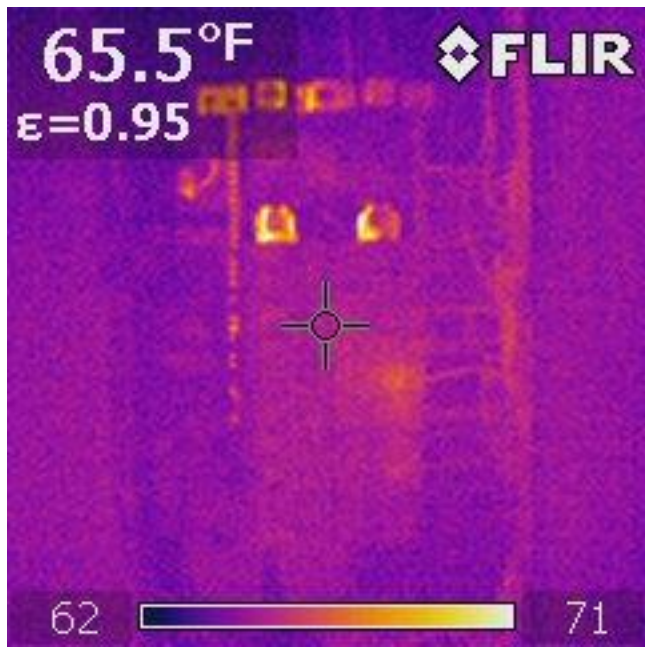
No evidence of overheating

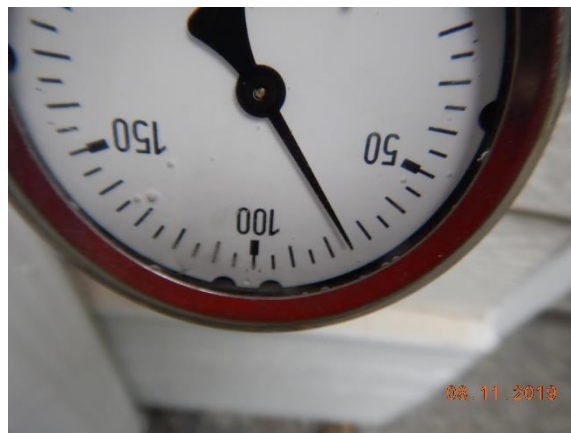
Measured water pressure: 75 P.S.I. Water pressure is adequate and not excessive

Water pressure is adequate and not excessive

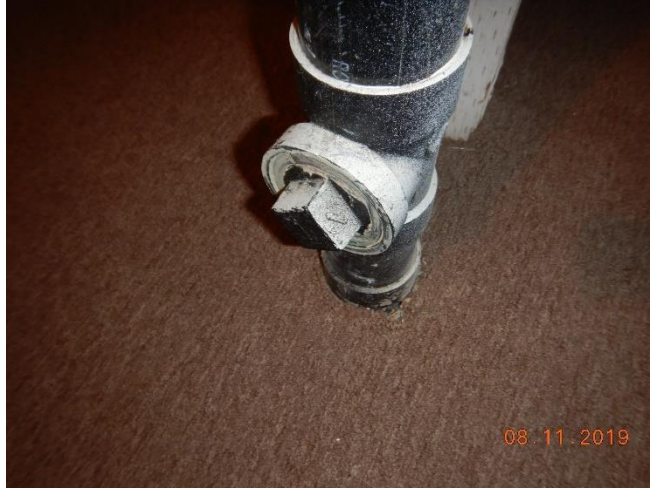
ABS waste lines

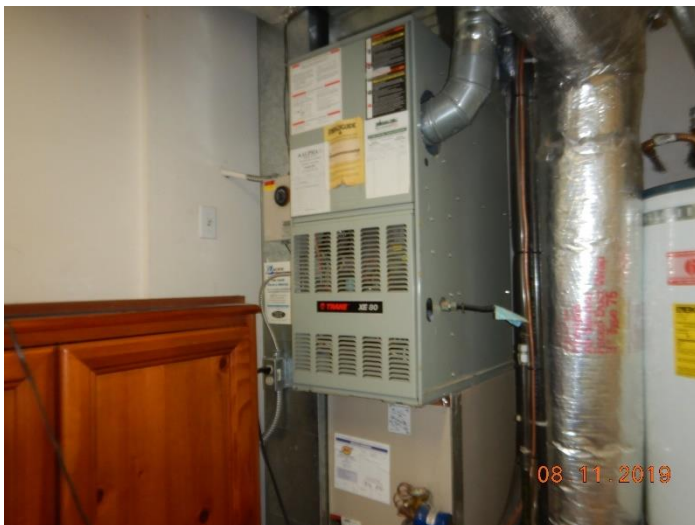
Furnace

Est. Useful Life new: 25 years
Serial number/year: Ansi 1993
Est. age of furnace: 23 years based on the age of construction of the home
Est remaining life: - The age of the furnace is 23 years. The remaining anticipated useful life expectancy is 2 years. The age of the air conditioning compressor is 15 years
Servicing: - Recommend furnace and air conditioning systems to be cleaned, serviced, and shown to be in good working order by a qualified furnace technician. The last service date for the systems was in 2015 per the tag on the furnace
- The air conditioning system compressor is not level which can result in premature wear of the system
- The inspection of the heat exchanger involves dismantling of the components of the furnace and is beyond the scope of a Home Inspection

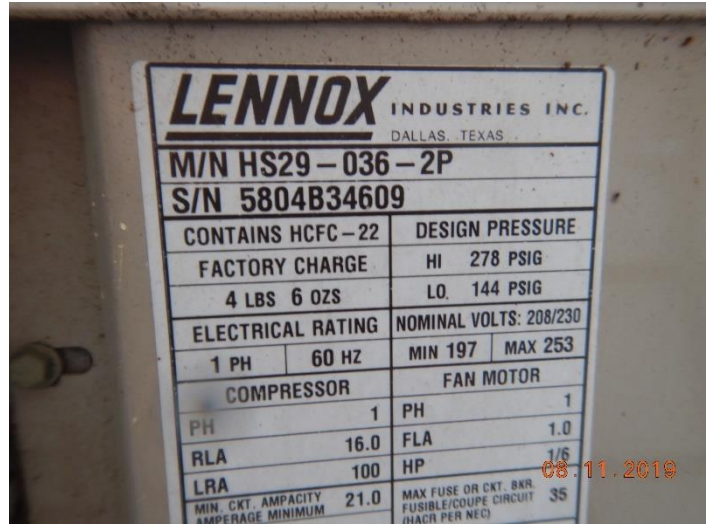
The compressor appears to be dated 2004

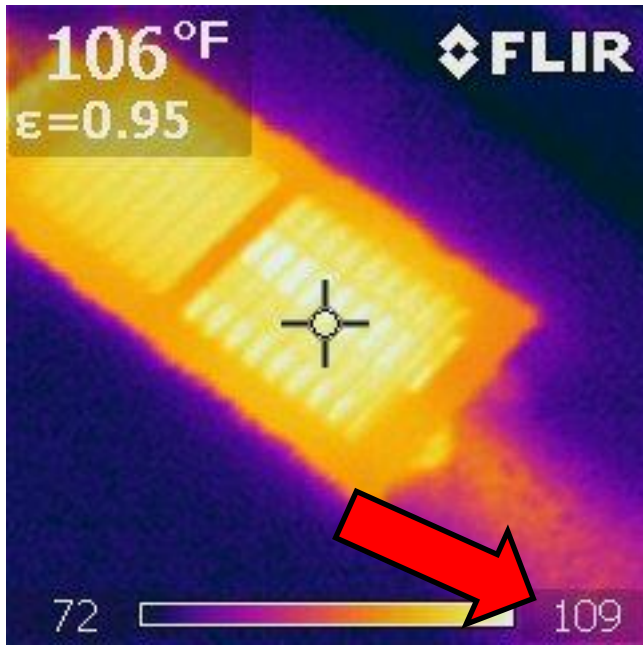
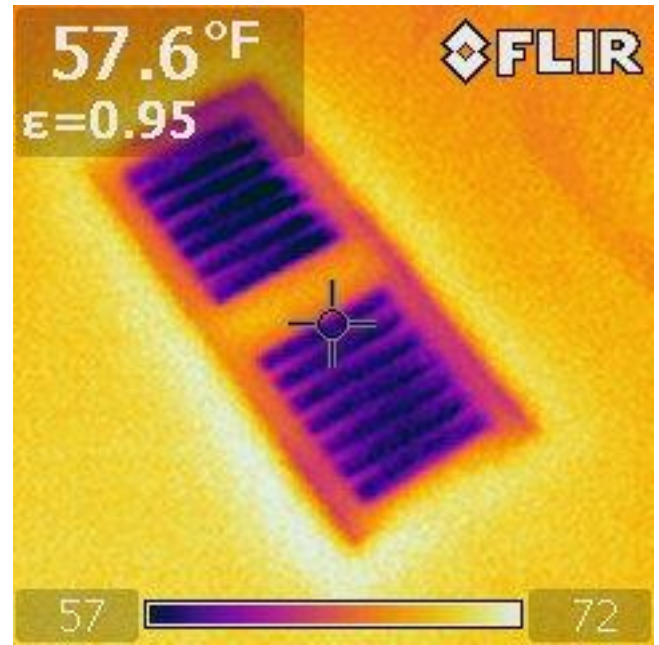
- Rating: 35-65 deg F
- @ return air: 70 deg F
- @ nearest register: 109 deg F
- Heat Gain: 39 deg F. Heat gain is within specifications of the furnace

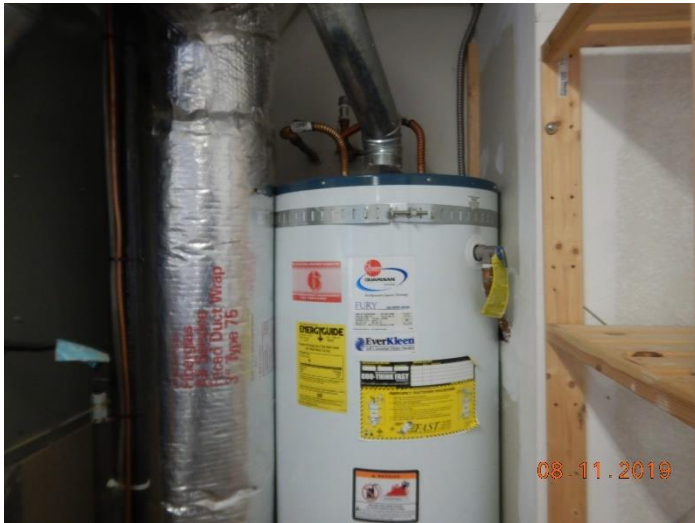
Water Heater

Est. Useful Life new: 12 years
Serial number/year: 2006
Est. age of heater: 13 years based on the serial number
Est. remaining life: - The water heater is fully functional with no visible evidence of rusting, however is past the end of its anticipated useful life expectancy by 1 year

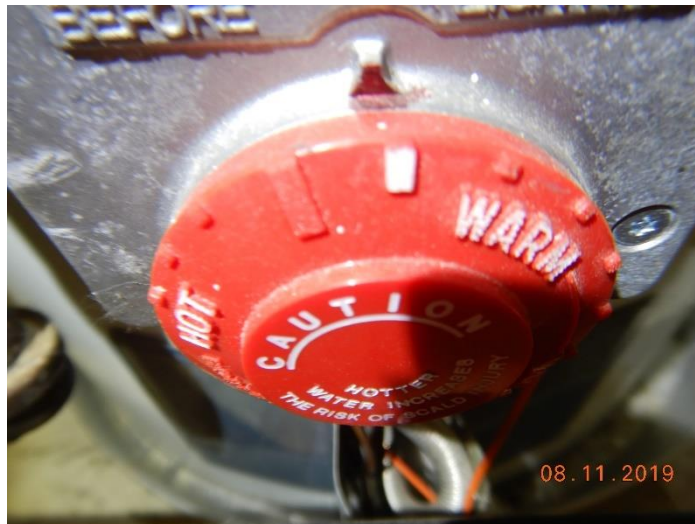
Temperature setting

- TPR valve: As per required
- Earthquake Straps: Installed
- Safe water temperature: 120 deg F per industry standards
- Measured temperature: - *Temperature not measured*

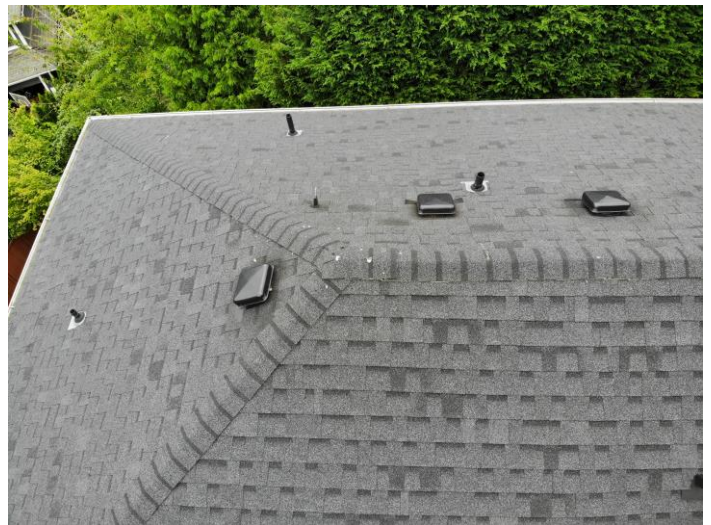
Roof (typical)

Estimated Pitch: 5:12
Material: Composition
Layers: 1+
How Inspected: From floor 2, the street, rear yard, and a drone
Roof access condition: Roof was not traversed as traversing the roof is deemed unsafe by the inspector
Condition: Overall satisfactory
Ventilation: Eave and roof hat vents
Plumbing Vents: Satisfactory
Flues: Satisfactory
Flashing: Satisfactory

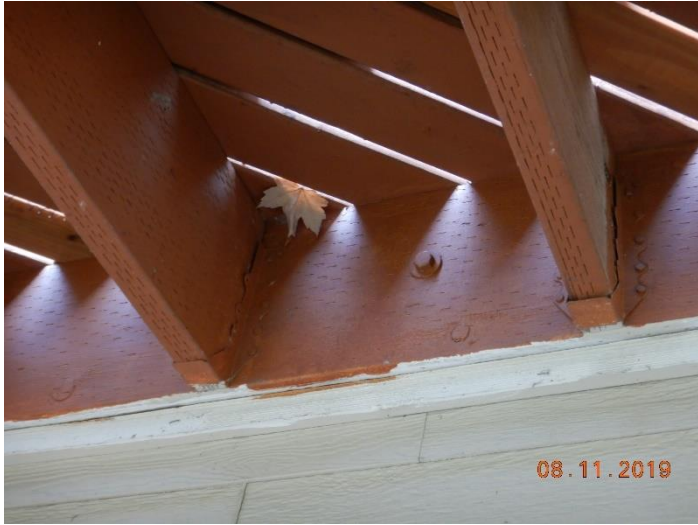
- Structure: Pressure treated joists, beams, and posts
- Decking: Cedar
- Condition: Overall satisfactory
- There is evidence of wood rot at the top side of several barricade posts at the deck
- Connection to structure: The deck appears to be adequately secured to the home with lag bolts
- Trip Hazard: None identified
- Handrails: A reasonable graspable handrail is installed
- Barricades: A reasonable barricade is installed

The deck is lag bolted to the home

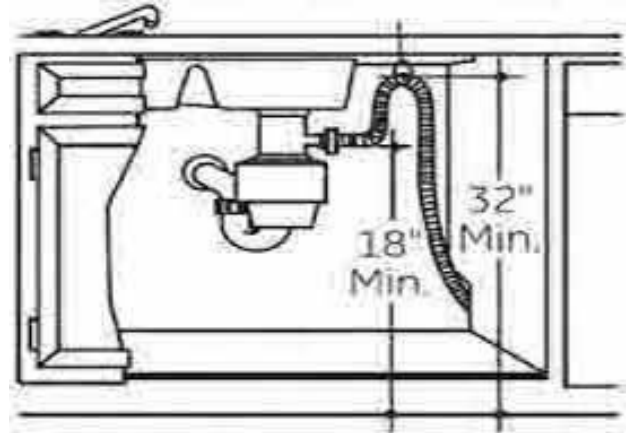
Proper dishwasher drain high loop

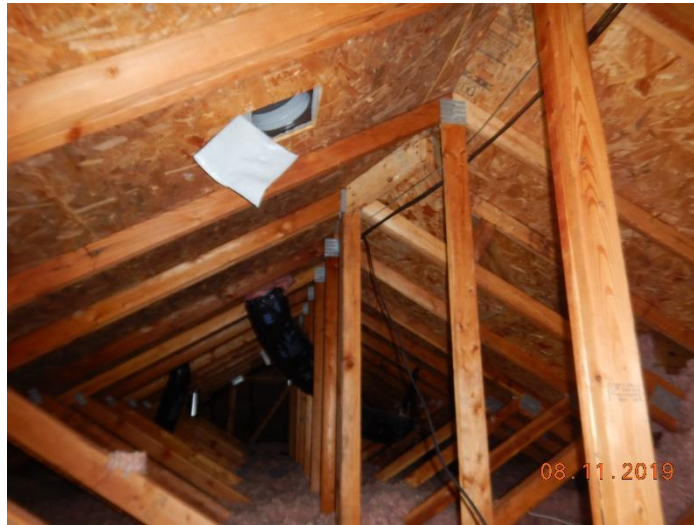
Attic (typical)

Visibility: Space is vacant
Access location: Master Bedroom closet
How viewed: From the attic access as all accessible areas are visible from the access
